Creep and Failure of Palaeozoic-Rock Slope

KOBAYASHI, Yoshimasa; NAKAGAWA, Akira

KOBAYASHI, Yoshimasa ...[et al]. Creep and Failure of Palaeozoic-Rock Slope. Bulletin of the Disaster Prevention Research Institute 1974, 24(3): 205-216

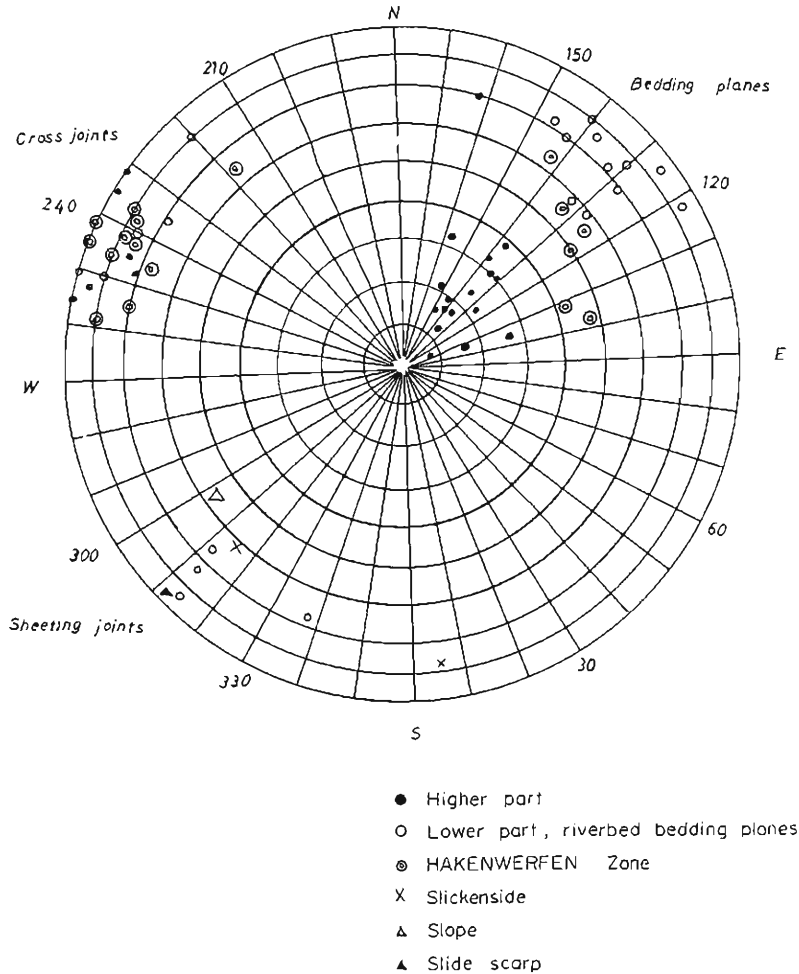
Fig. 2. Distribution of joint orientations in a higher and lower part of the slope.

A polar representation of the distribution of joints at an old slide scarp in the uppermost part of the slope and at the river bed is given in Fig. 2. In the figure the poles for the slope surface (N30W/55N) as well as for the old slide scarp (N55W/80N) are also given.

It is noted in the higher part of the slope that the orientation of the slide scarp is nearly coincident with the average of those of sheeting joint. The angle between the average orientations of sheeting joint and of the slope as a whole is about 20 degrees. The gaps between joint surface in the upper part are 5 to 15 cm for bedding joint, 1 to 25 cm for cross joint and 5 to 10 cm for sheeting joint.

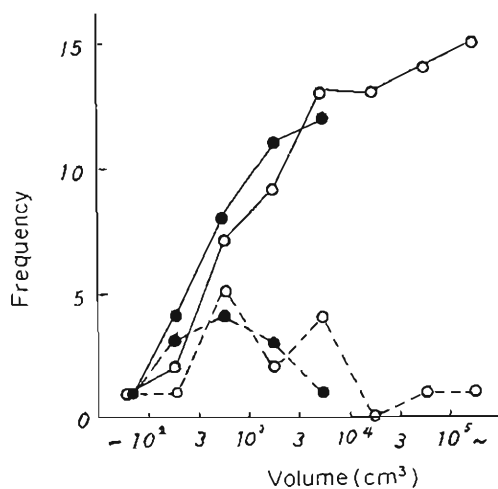
Fig. 3. Size distributions of debris; ○ sandstone, ● slate; size frequency curve, — size accumulation curve.

- in case of sandstone, 50 to 200,000 cm³ and
- in case of slate, 90 to 4,000 cm³ (see Fig. 3).

The most frequent sizes correspond to the class 300 to 1,000 cm³ for both types of rock.

The volumes of the rock blocks having fallen prior to the slides are 310,000 and 225,000 cm³, which belong to the class of the biggest size. The debris are in general angular and the angle of friction of the aggregate is estimated to be higher than
